A Unique Case of a Titanium Plate Failure Following Osteosynthesis of a Forearm Fracture

Key words: Implant failure; Titanium plate; Plate breakage; Forearm fracture

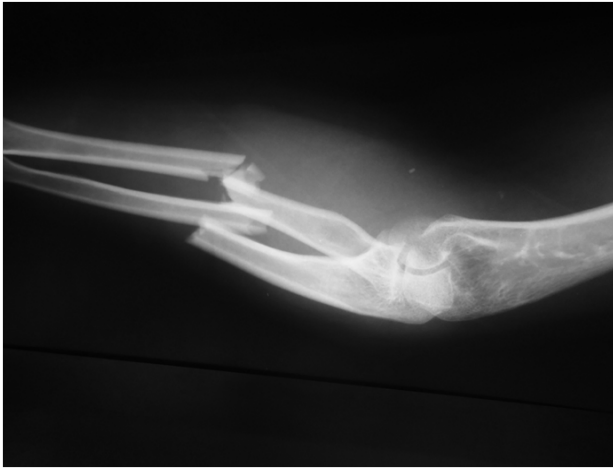
A 52-year-old woman that had been involved in a car accident had suffered a grade I open comminuted fracture of the middle third of both radius and ulna following a direct blow on her forearm (Figure 1). Since the fracture was unstable, surgical treatment was decided.

Figure 1 Fracture of the middle third of both radius and ulna, suffered by a 52-year-old woman involved in a car accident.

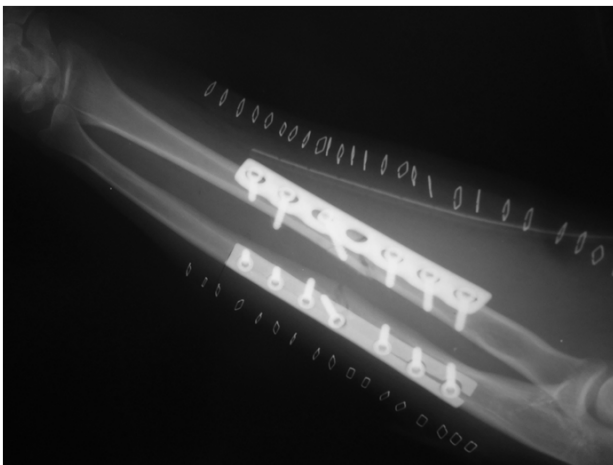
with an one third 7-hole titanium plate (Synthes, Solothurn, Switzerland), while a similar plate was applied to the ulna. Intraoperatively, the surgeon had the feeling that the proximal screw of the ulnar plate had been somewhat over-tightened, but there were no further worrying signs, nor episcopal signs of implant insufficiency or failure.

The immediate postoperative X-rays revealed a longitudinal crack beginning at the proximal part of the ulnar plate end passing through the two proximal plate holes and reaching the third hole (Figure 2).

Figure 2 The immediate postoperative X-rays revealed a longitudinal crack beginning at the proximal part of the ulnar plate end passing through the two proximal plate holes and reaching the third hole.

A brittle fracture usually occurs because of the presence of cracks in the structure of the material that are either due to tiny defects resulting from a manufacture deficiency or they develop later following implant loading. In this case, over-tightening of the proximal screw may have triggered crack initiation. This highlights another possible disadvantage of titanium implants, since Titanium's lower ductility gives less tactile warning when screws are over-

Such a crack can extend rapidly at applied load levels, which are nominally well within the linear load-displacement response of the component. Since the immediate appearance of the crack could not be due to a possible fatigue fracture and its propagation parallel to the implant's long axis could not be attributed to increased shear or bending forces, both were evidently the result of a brittle fracture.

Since there was no loss of reduction or displacement of the plate and screws we decided against an immediate revision of the osteosynthesis and a protective above-elbow splint was applied for 2 months in order to facilitate fracture healing.

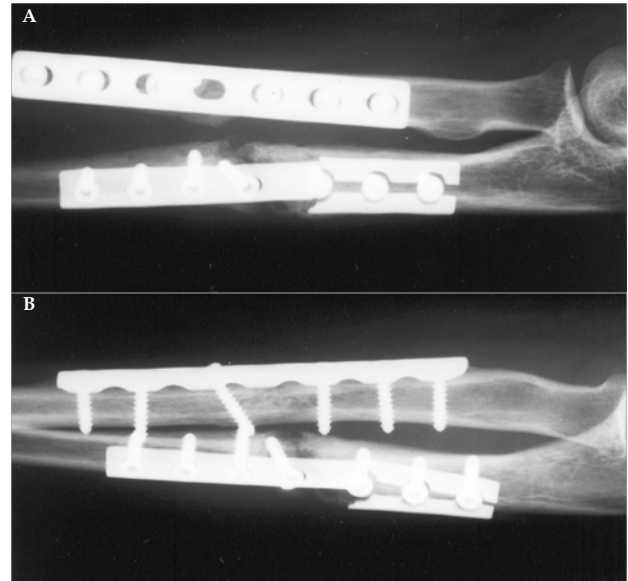
On six-month follow-up, X-ray control revealed that there was an additional transverse crack through the third hole, causing a complete separation of the plate fragments and leading to a complete loss of contact between the proximal plate and screws (Figure 3).

Figure 3 X-ray control on six-month follow-up revealed that there was an additional transverse crack through the third hole, causing a complete separation of the plate fragments.

The transverse crack became apparent one year postoperatively, nine months after the last radiographic control where it was not evident. This crack displayed the characteristics of a fatigue fracture. A fatigue fracture is usually the result of cyclic loading, where the applied force exceeds the resistance of the material. In a fatigue fracture there are signs of plastic deformation of the material, which precedes the initiation and propagation of the crack. A fatigue fracture will have two distinct regions; one being smooth or burnished as a result of the rubbing of the bottom and top of the crack. The second is granular, due to the rapid failure of the material that resembles a brittle fracture.

In this case the preceding brittle fracture has rendered the plate more prone to a possible fatigue fracture. The failure of the fracture to unite, in the absence of adequate stability in the fracture site, resulted in increased instability and the implant was subsequently led to complete failure.

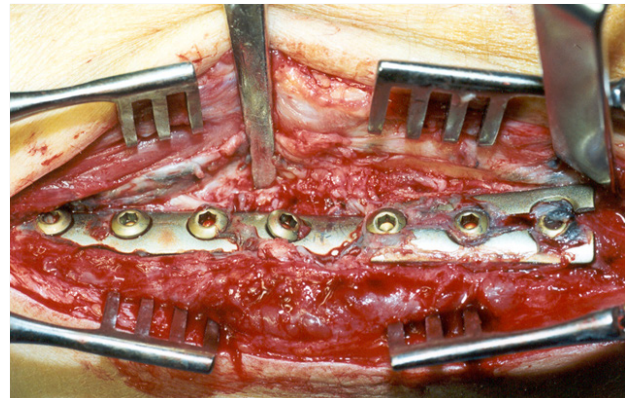
Since there was radiologic evidence of pseudarthrosis at the fracture site and the osteosynthesis had failed, revision surgery was decided (Figure 4).

Figure 4 Intraoperative picture of the fragmented plate.

The broken plate and the screws were removed and a new osteosynthesis was performed with a stronger 9-hole LC-DCP titanium plate (Synthes, Solothurn, Switzerland) and was augmented with autologous bone graft.

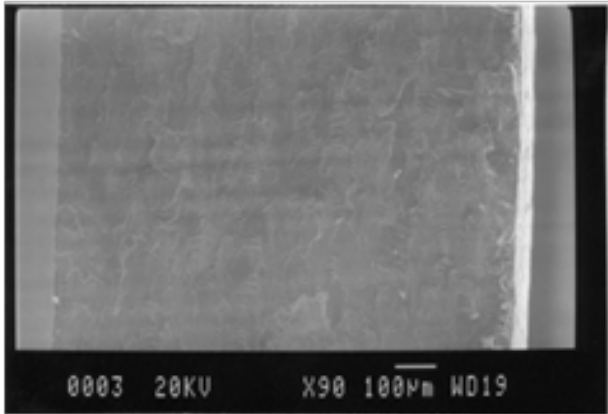
Moreover, scanning of the plate's surfaces at the fragmentation site with electronic microscope showed that appearance of the longitudinal crack was granular and typical of a brittle fracture (Figure 5), with no evidence of plastic deformation.

Figure 5 Electronic microscope scanning showed that appearance of the longitudinal crack was granular and typical of a brittle fracture.

In conclusion, our experimental evidence suggests that the longitudinal crack was the result of a brittle fracture that might have been triggered by screw over-tightening. This subsequently led to the transverse fatigue fracture as the result of the increased and sustained cyclic loading.

For everyday clinical practice, our findings indicate that surgeons should be extremely cautious when tightening titanium screws in order to avoid overtightening. Moreover, the appearance of even a minor crack in the immediate or early postoperative radiographs may represent an implant brittle fracture with a highly unpredictable pattern of progression. In such a case, the decision for an immediate revision procedure may be justified.

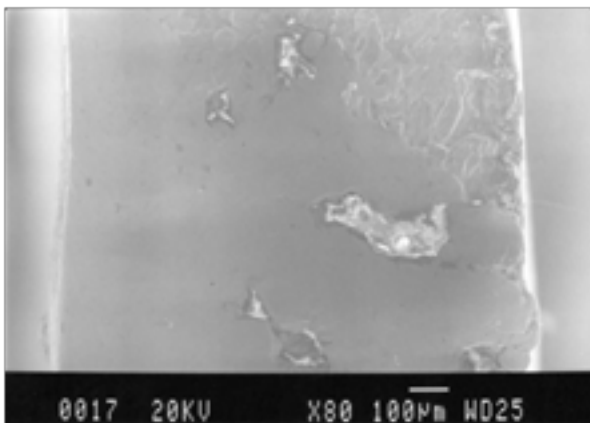
On the contrary, the transverse crack displayed characteristics of a fatigue fracture with a smooth, burnished surface (Figure 6).

Figure 6 Electronic microscope scanning revealed that the transverse crack was a fatigue fracture with a smooth, burnished surface.
